MANOLO HEALTH CENTER SITE VISIT REPORT

Christopher Hara

Mzuzu University

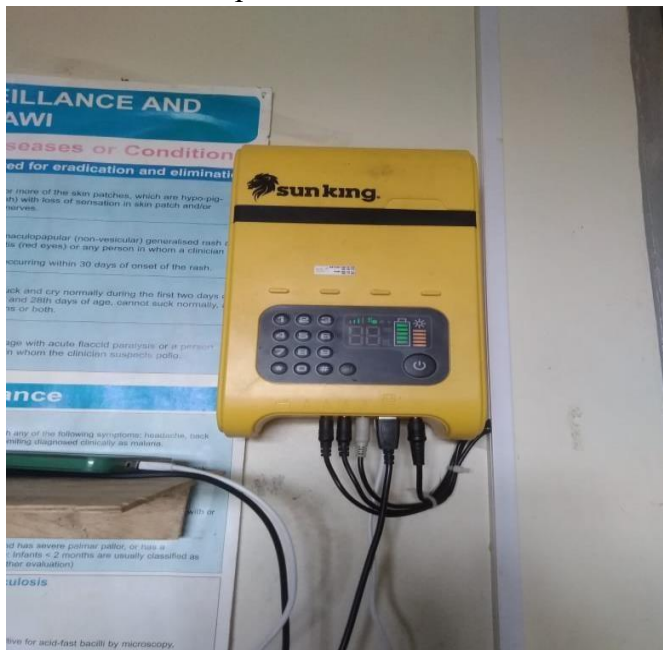
This solar Pico was donated by Sun-King solar company, this system consists; 4 LED bulbs and a USB port for phone charging. The 4 LED bulbs have been unevenly installed to serve as a lighting source for the hospital.

Lighting is only accessed in the doctor's office, treatment room, Ward room/maternity wing and outside the facility to provide security. The solar PICO is also used to charge or power some small appliance which needs less power to operate like blood level taster. Besides the aforementioned uses, the system also serves as a charging point for mobile phones from staff and some patients. Once fully charged the solar Pico provides lighting for at least 9 to 10 hours. This solar Pico is the only hope for the whole facility in as far energy access for lighting and phone charging is concerned.

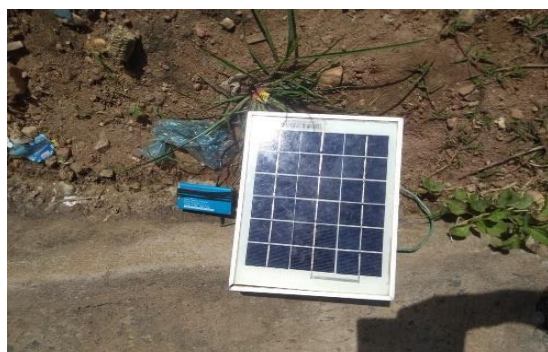
Due to lack of electricity, pregnant women patients and their guardians are forced to carry their own solar panels to charge their phone through a local process called battery boosting as shown in the picture.

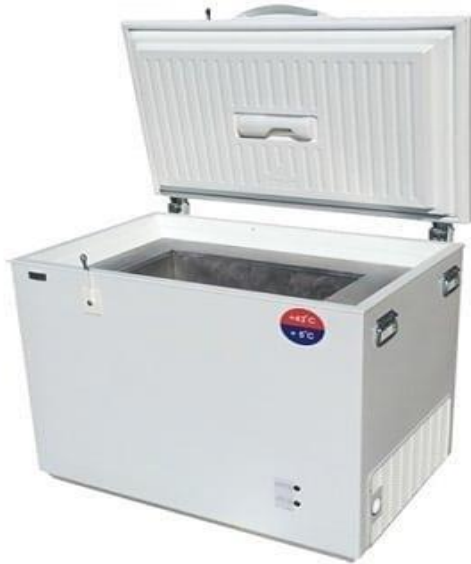
The health center has a solar powered vaccine fridge which has a separate system. The solar fridge was donated by a government project. the fridge operates 24hrs and so far, there are no problems faced regarding the fridge.

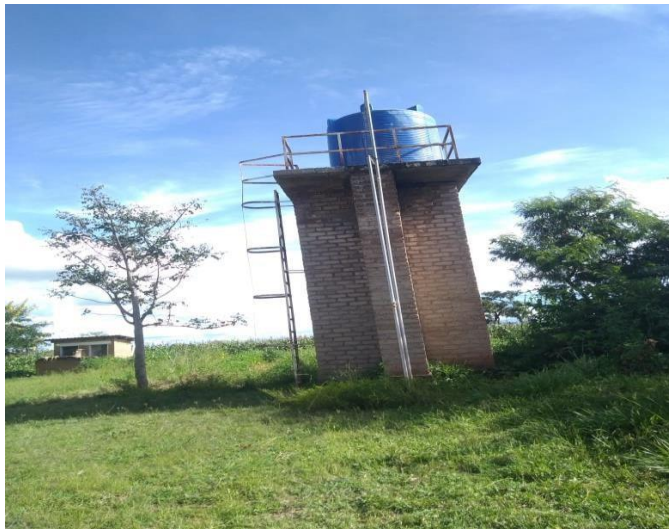
The facility has a solar water pumping system which supply enough water to the whole health facility. It also has a stand-alone system which consists of a 1000L tank, solar Panels and ground water pump.
